HA NOI PETROLEUM PRODUCTS STORAGE  
THANH AM, NORTH VIETNAM  
2103 10553E

THIS BRIEFING BOARD DEPICTS THE PRE-STRIKE AND POST-STRIKE POL STORAGE CAPACITY OF HA NOI PETROLEUM PRODUCTS STORAGE THANH AM.

# HA NOI PETROLEUM PRODUCTS STORAGE

THANH AM, NORTH VIETNAM

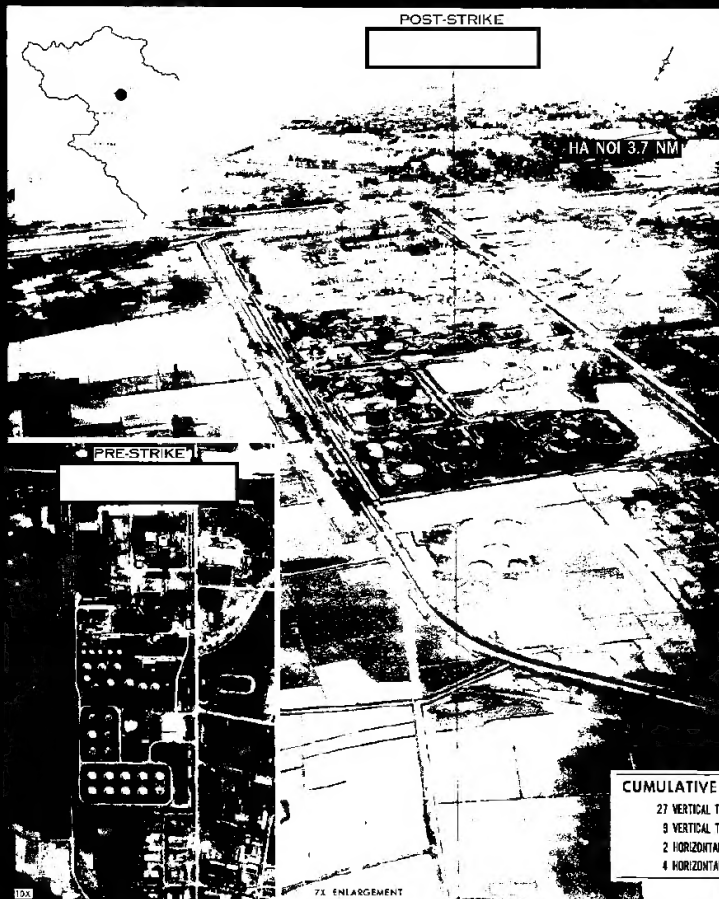
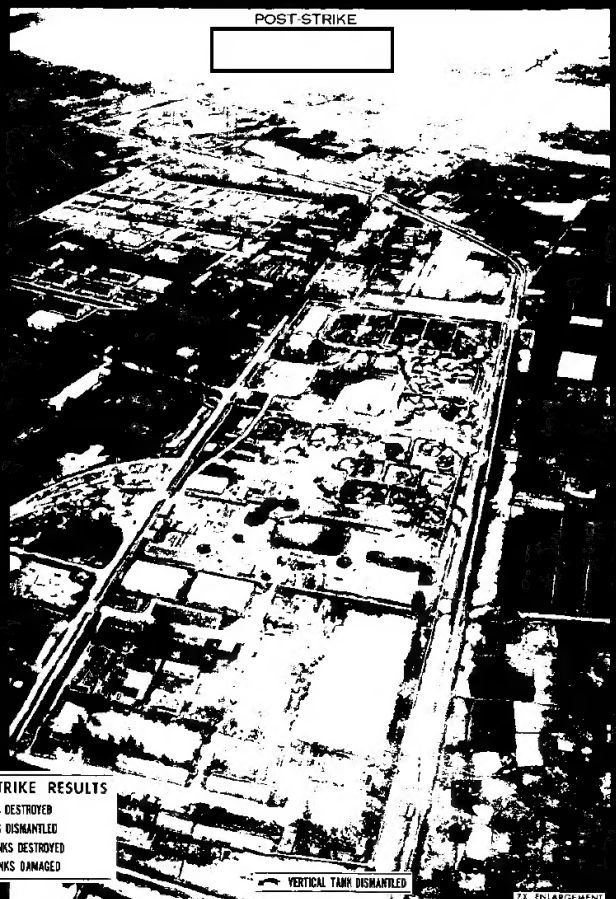
## CUMULATIVE STRIKE RESULTS

27 VERTICAL TANKS DESTROYED  
9 VERTICAL TANKS DISMANTLED  
2 HORIZONTAL TANKS DESTROYED  
4 HORIZONTAL TANKS DAMAGED
